# PROPERTY INSPECTION REPORT

### 251 Penny Lane, Liverpool, PA 17045

Report Prepared Exclusively For Billy Shears Buyers' Agent: Loretta Martin, Apple Realty Services Date of Inspection: 4/15/2022

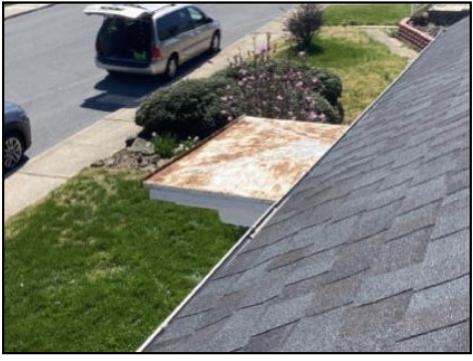
2.4. The front porch roof was constructed of metal, which was observed to have been rusting at the time of inspection. The metal flashing on the front wall above the porch roof had peeling paint at the time of inspection. This paint should be scraped and repainted to preserve the life of the flashing.

Metal front porch roof was rusting

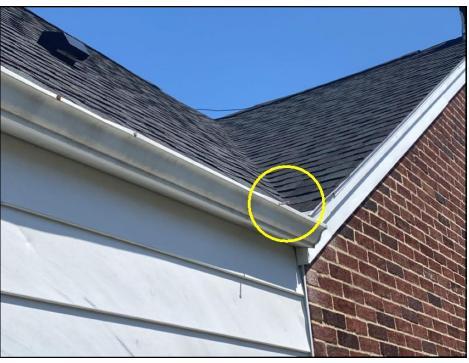
3.4. A downspout or downspouts continued into a drainage pipe entering the ground; this typically continues in a drainage pipe underground and terminates in a discharge point at the street curb. A home inspection does not include checking the underground drainage piping for leaking, or verifying that drainage is reaching this point. You should verify that drainage is reaching a point at least 6 feet outside the foundation. LOCATION: garage exterior, front of the home 3.5. A gutter mounting spike was observed to be detaching at the left rear near the back chimney.

Gutter spike loose at left rear

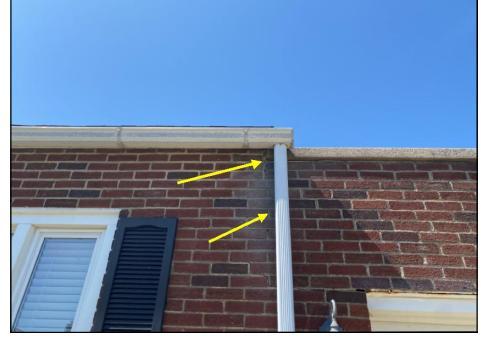
3.6. Staining and mortar deterioration was observed at the front of the home, to the left of the garage door opening. Staining indicated that the downspout had been leaking. Testing of gutter drainage is beyond the scope of a home inspection; you should ask the seller about this condition, and inspect this area during a rainstorm to evaluate for leakage. The mortar damage in this area should be sealed, or the mortar removed and repointed, to avoid moisture intrusion into the home.

Staining and mortar deterioration at front of home

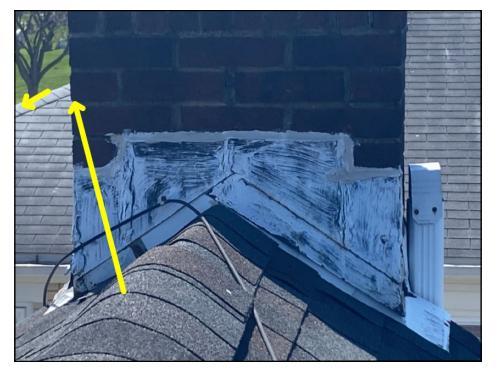
4.1. Roof flashing was generally old and showed general moderate corrosion throughout the roof. Flashing should be inspected annually and replaced before it begins to leak.

Chimney flashing was discolored

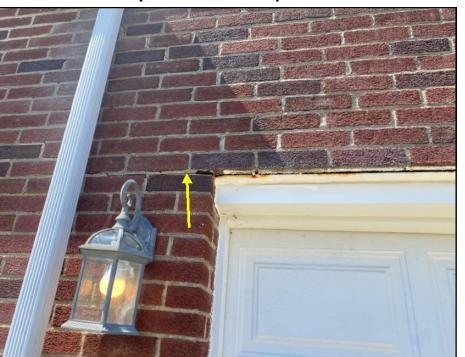
2.2. Step-cracking in the brick mortar was observed at both top corners of the opening for the overhead garage door. Door openings commonly crack at the top corners because they are the highest points of stress movement. The lintel, or doorway top support, was made of metal, which expands and contracts according to temperature. This movement of the metal stresses the mortar joints at the corners of the door opening. Cracking such as this with a metal lintel is common, and the mortar should be patched and re-pointed as necessary to prevent moisture damage to the exterior wall structure and home interior, and to prevent development of microbial growth such as mold. If the cracks grow in size or width, or become more widespread, you should consult with a qualified and licensed contractor for evaluation and repair.

Cracking at garage door opening

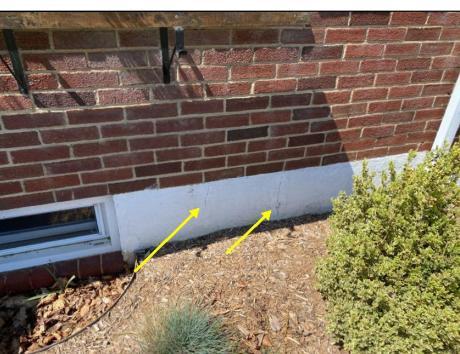
2.3. Concrete Masonry Unit (CMU) foundation walls had moderate stepped cracking visible in mortar joints. Cracking should be patched to avoid freeze damage, and the cause of cracking should be determined and corrected. Concrete normally cracks over time as it dries, and it may not be an indication of a deeper problem. LOCATION: front of the home, rear of the home

Surface cracking of the foundation exterior coating

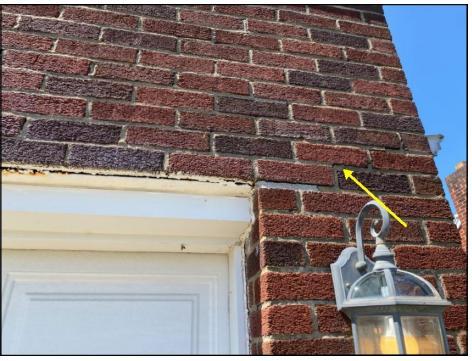
Cracking near corner of overhead garage door opening

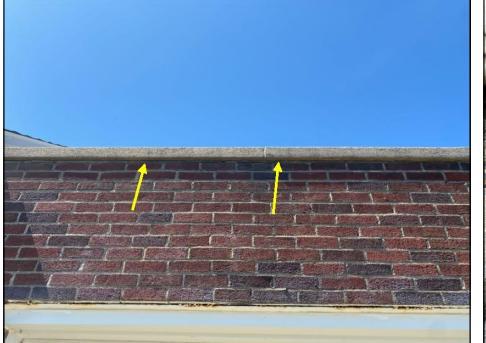
Seal or repoint the mortar cracks here to prevent moisture and pest intrusion

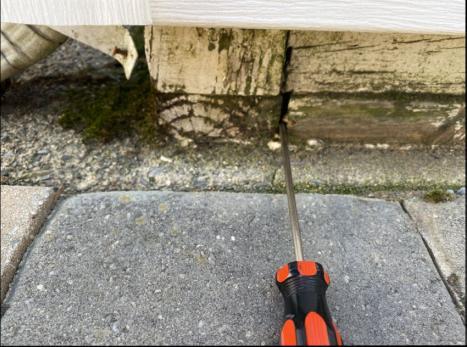
2.6. The area under the dining room appeared to previously have been a patio. There was stacked 2x4 lumber under the floor in this area, and upon probing was determined to be rotting on the inside. Untreated wood in contact with the ground will absorb moisture, creating rot and making the area inviting to wood-destroying insects and fungi. This area should be evaluated by a qualified contractor, and repaired or replaced as necessary.

This area of exposed wood under the dining room was deteriorating and rotting on the inside

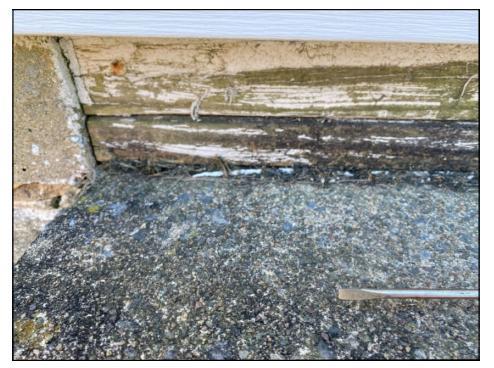
Wooden floor support under the dining room was in contact with the ground and deteriorating

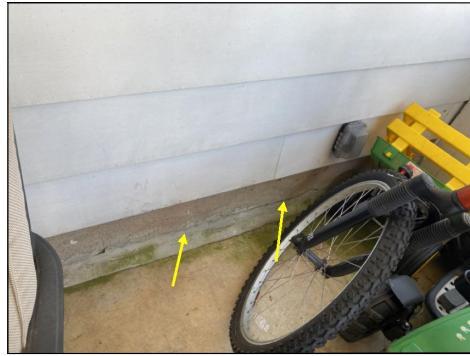
Some cracking of the foundation parging was observed on the rear patio

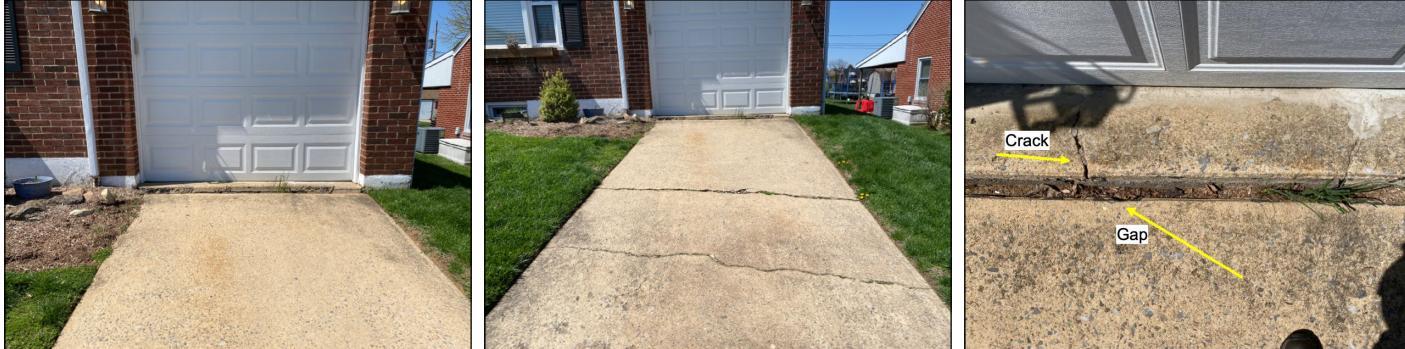
6.3. Common cracks (1/4-inch or less) were visible in the driveway. Cracks exceeding 1/4-inch should be filled with an appropriate material to avoid continued damage to the driveway surface from freezing moisture.

Driveway surface had cracks

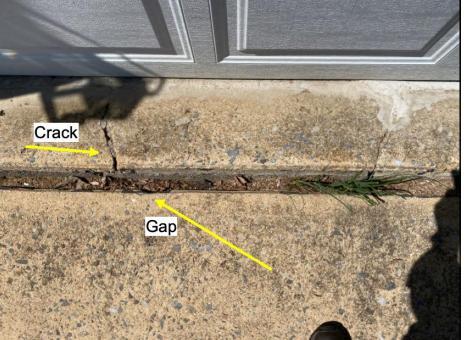
Gap between the driveway apron and garage slab floor; some cracking of the garage slab is observed

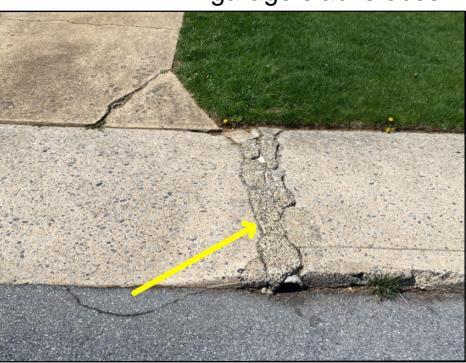
6.6. An area of the front sidewalk to the right of the driveway apron was uneven, and presented a trip hazard at the time of inspection.

This area of the front sidewalk was uneven and presented a trip hazard

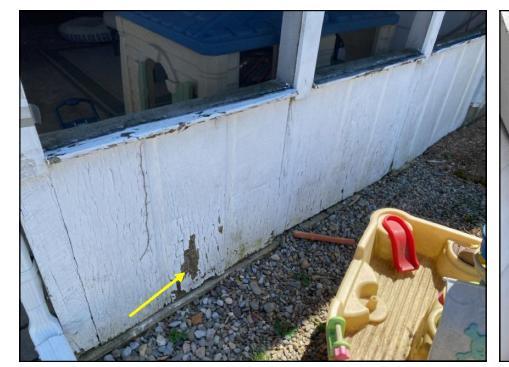
7.6. Wood cladding on the patio wall at the rear of the home was deteriorating from exposure to weather. Wood that is not treated for exterior use will rot over time. This cladding should be replaced. Exterior plywood cladding such as T-111 is appropriate for this application.

Cladding on back patio wall was deteriorating

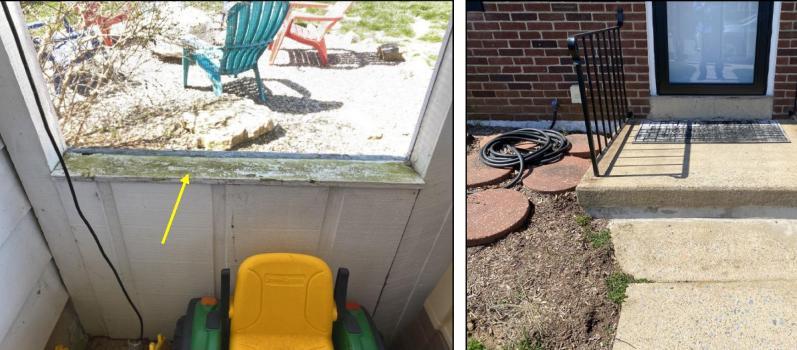
Algae growth was observed on the rear screen porch

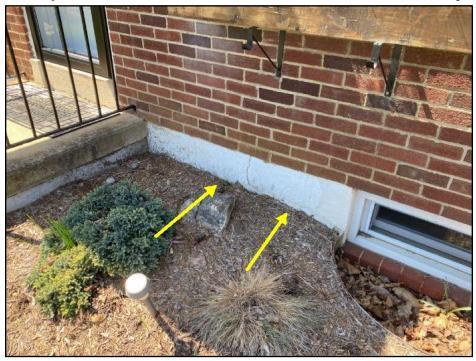
9.1. The home had areas of neutral or negative drainage that will send rainwater runoff toward the foundation. The ground should slope away from the home a minimum of ¼-inch per foot at least six feet from the foundation. You should have these areas re-graded to improve drainage near the foundation. LOCATION: at the left and front of the home, particularly to the right of the front door. NOTE: this area corresponds to elevated moisture on the front basement wall.

This area of grading drains toward the foundation, near elevated moisture in the basement

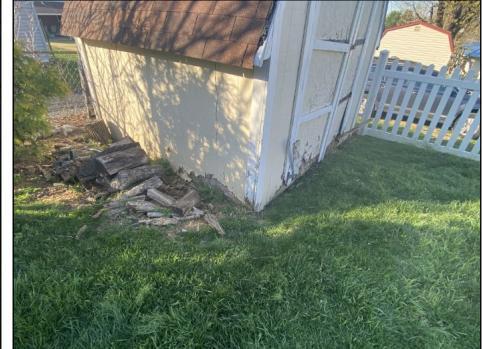
The rear shed had deteriorated doors and siding

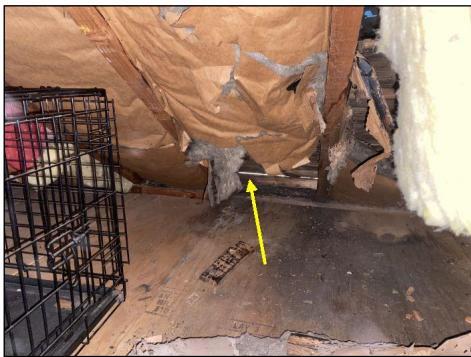
2.4. Space allowing sunlight through were observed at the soffits, near where the fascia attach to the home. These spaces may allow insects to enter and nest, and allow exterior air to infiltrate the interior space. These spaces should be sealed.

Sunlight visible in soffit area

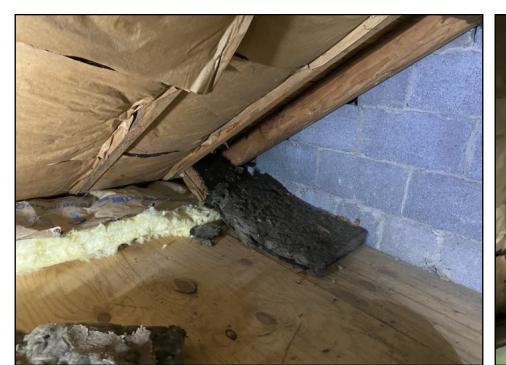
Batt insulation had fallen out of the rafter spaces

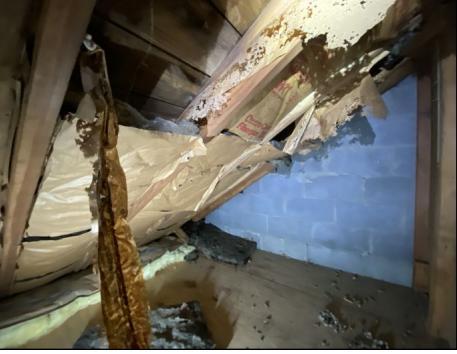
Batt insulation paper facing was deteriorated

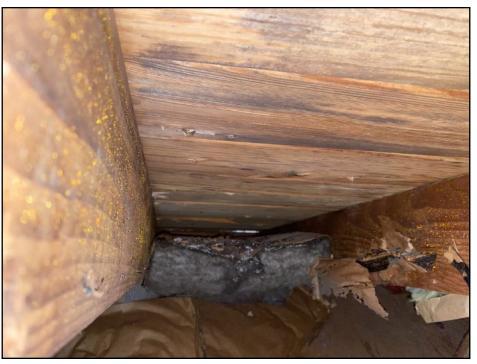
Batt insulation showed varying levels of deterioration

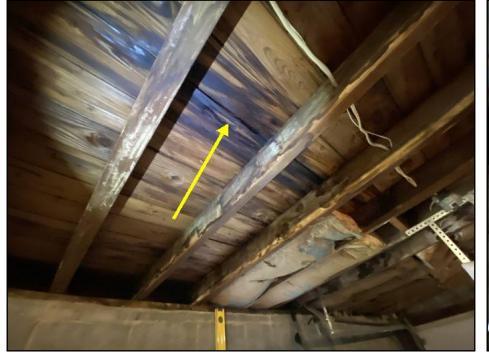
The dark area under the roof could be leakage or resin seepage from the wood

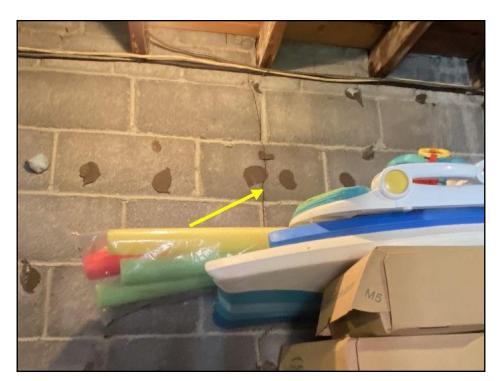
2.4. A crack was observed to be going through the center of a block on the interior side of the garage. The cause of this crack is unknown. A straight crack in a masonry wall or foundation can be due to shrinkage of the concrete. Concrete block walls might shrink or expand in response to moisture changes. Another possible cause is the building of additions in the rear of the home, and how they affect the structure of the home. Having stated these possibilities, it should be noted that there was no deflection or movement observed in the block at the time of inspection; if this condition were present, it could indicate structural movement. If the crack expands or the block becomes displaced, the wall should be evaluated by a qualified contractor.

Crack through block on the garage interior wall

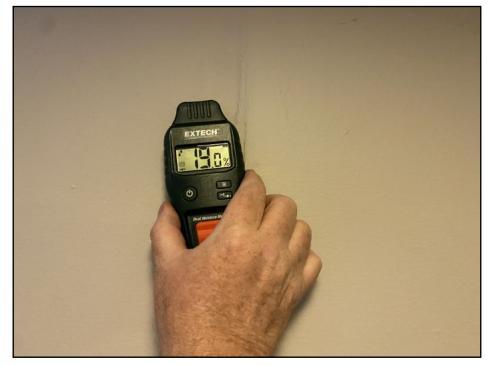
1.9. In the finished part of the basement, moisture levels in the wall near the window showed elevated levels of moisture. This condition indicates high moisture levels in soil near the foundation. This area corresponds to an area of negative grading at the exterior of the home to the right of the front door. Excessively high moisture levels in soil supporting the foundation can cause various structural problems related to soil movement. The condition should be corrected.

Moisture level on front basement wall was elevated

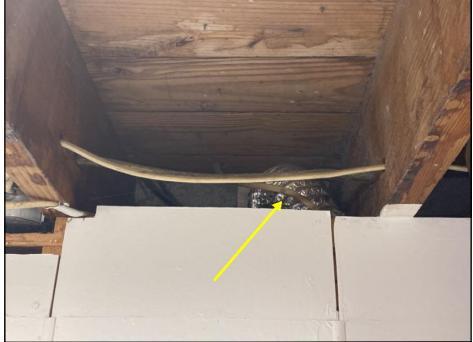
5.6. The dryer exhaust duct was kinked and/or crushed where it exited the back of the dryer. Space limitations made proper installation difficult. This condition creates a restriction in dryer exhaust that can result in lint accumulation or duct blockage, both of which are potential fire hazards. Restricted exhaust venting can also cause dryer overheating that can shorten the expected long-term service life of the dryer. Special hardware is available that is designed to allow proper venting in areas with space limitations. The Inspector recommends installation of an adapter that will not restrict dryer exhaust air flow.

This foil dryer vent hose should be replaced with rigid type vent pipe

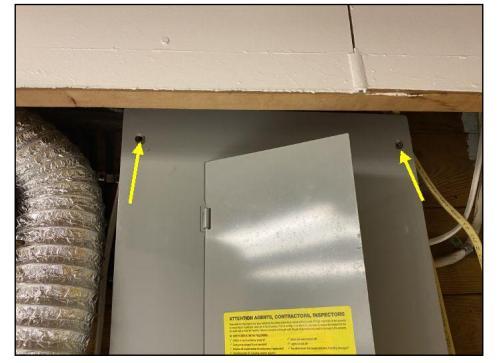
2.6. The dead front cover of the electrical service panel was missing screws. The Inspector recommends that appropriate screws be installed to securely attach the dead front cover.

Missing screws in service panel

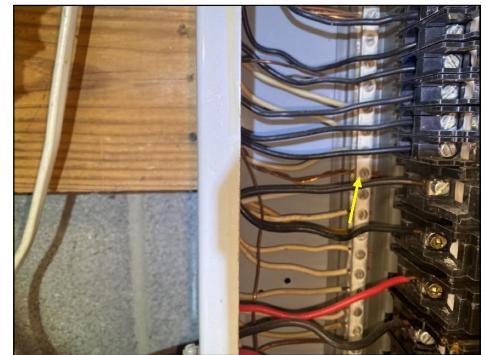
5.5. Double-tapped ground wires (two wires terminated in a space designed for one wire) were observed in the ground & neutral termination bar. Some electrical service panels were rated for double-tapped ground wires, meaning that two ground wires were allowed to terminate under the same lug. This installation practice was permissible at the time the home was built, but is no longer allowed in new installations. If flickering lights or intermittent power at receptacles are observed in the future, have the panel checked by a qualified electrician.

Double-tapped ground conductor in ground bar

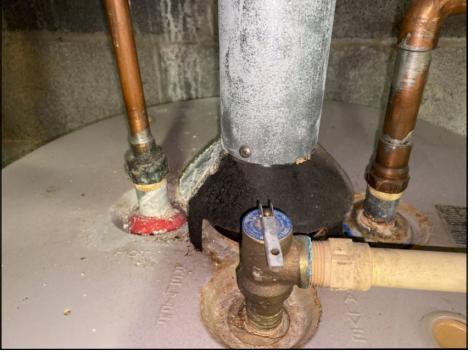
Corrosion on and near water heater vent hood

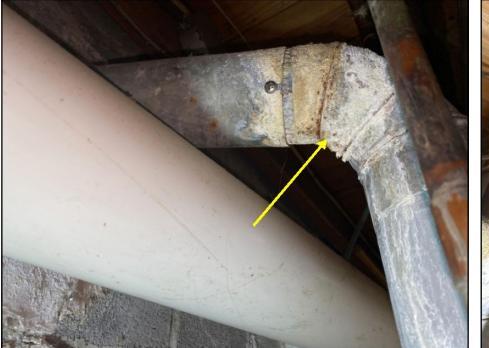
White corrosion on water heater exhaust pipe indicated exhaust problems

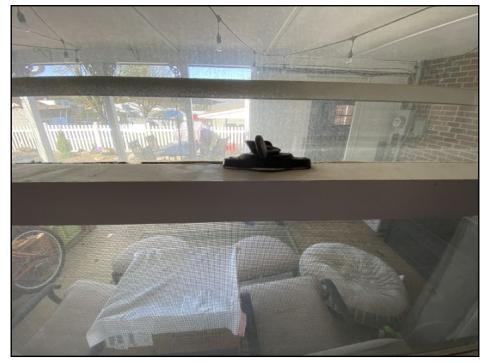
Family room patio side right window would not lock

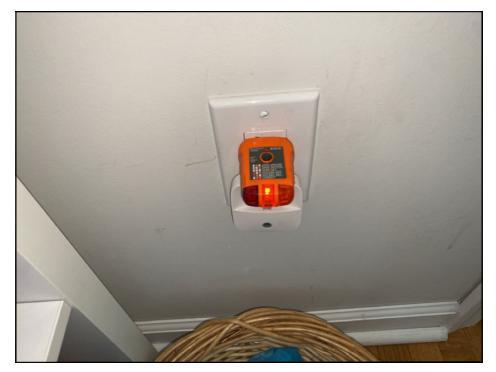
3.1. An electrical receptacle in the living room near the front door had a wiring fault at the time of inspection. This condition should be corrected by a qualified electrical contractor.

The outlet nearest the front door had a wiring fault

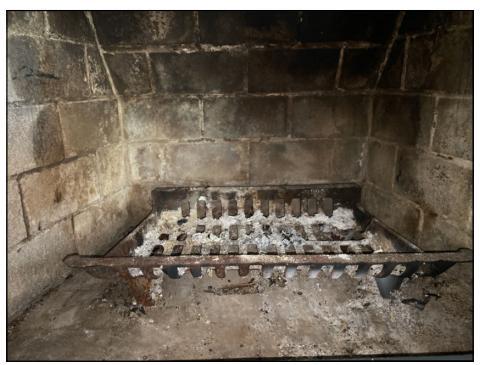
Interior of the fireplace was dirty

4.4. Before burning wood in the fireplace, you should have a Level Two inspection done of the fireplace by a certified chimney sweep. They will clean creosote from the chimney flue and evaluate the condition of the firebox and flue. Chimney fires due to dirty flues are numerous every year; a Level Two inspection is a very important part of the safety of your home.

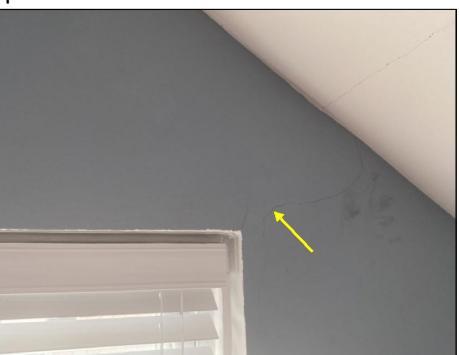
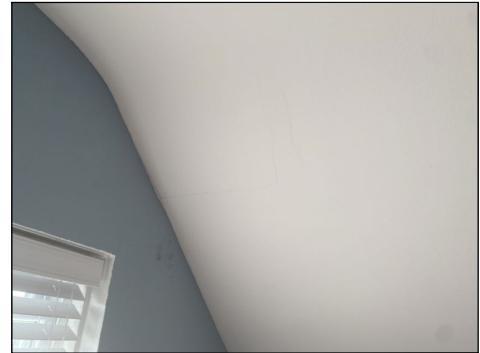
2.2. Minor cracks at the corners of doors and windows in walls in a bedroom appeared to be the result of long-term settling. Some settling is not unusual in a home of this age and these cracks are not a structural concern. They should be repaired and repainted. LOCATION: upstairs front bedroom

Stress cracks in the upstairs front bedroom

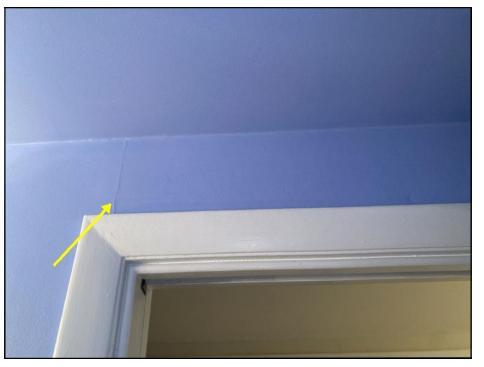
5.2. Minor cracks at the corners of doors and windows in walls in the upstairs bathroom appeared to be the result of long-term settling. Some settling is not unusual in a home of this age and these cracks are not a structural concern.

Stress crack above the upstairs bathroom door
