# PROPERTY INSPECTION REPORT

### 251 Penny Lane, Liverpool, PA 17045

Report Prepared Exclusively For Billy Shears Buyers' Agent: Loretta Martin, Apple Realty Services Date of Inspection: 4/15/2022

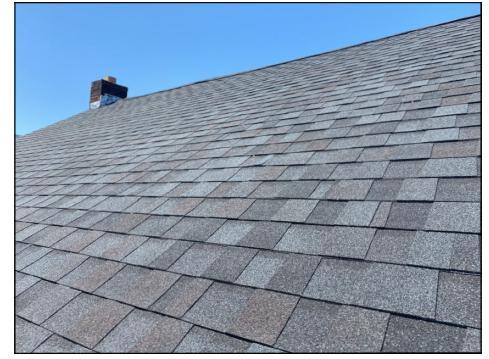
Front roof surface

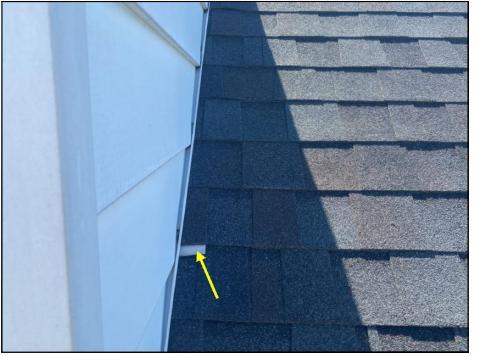
Step-flashing on the rear dormer

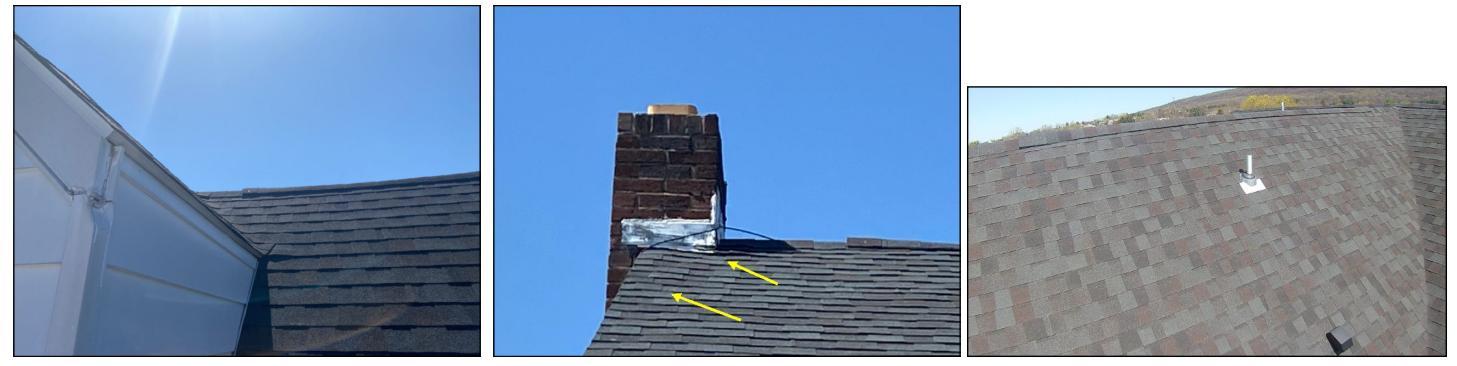
2.1. The gable roof had areas of minor undulation or 'waviness' on the roof surface, and a raised hump area on the main roof ridge vent. This is typically caused by improper installation or deteriorating roof sheathing. The roof-covering materials appeared to be adequately protecting the roof at the time of inspection. The second floor ceilings were finished, so examination of the sheathing condition from the inside was not possible. You should regularly examine the gable roof surface for changes in these areas. If the condition worsens, consult with a qualified roofer for evaluation.
2.2. Damage to the asphalt shingles from buckling was observed at various points around the chimney flashing. These raised shingles are a potential entry point for water and should be repaired.

Bulging and buckling shingles near the chimney

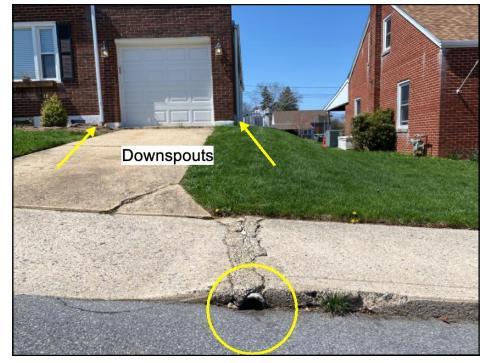
Drainage opening in the curb opposite downspout terminations into ground

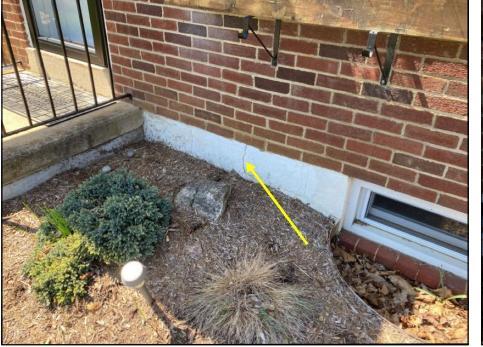
2.3. Concrete Masonry Unit (CMU) foundation walls had moderate stepped cracking visible in mortar joints. Cracking should be patched to avoid freeze damage, and the cause of cracking should be determined and corrected. Concrete normally cracks over time as it dries, and it may not be an indication of a deeper problem. LOCATION: front of the home, rear of the home

Surface crack on foundation

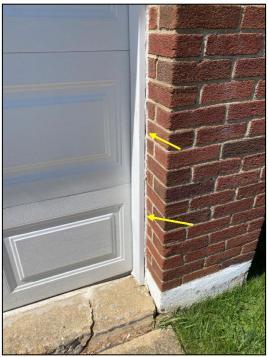
2.5. Exterior trim at parts of the home exhibited deterioration at the time of inspection, and the sealant or caulking should be redone in these areas to prevent moisture intrusion to the home. LOCATION:garage exterior

These openings in the brick molding should be resealed

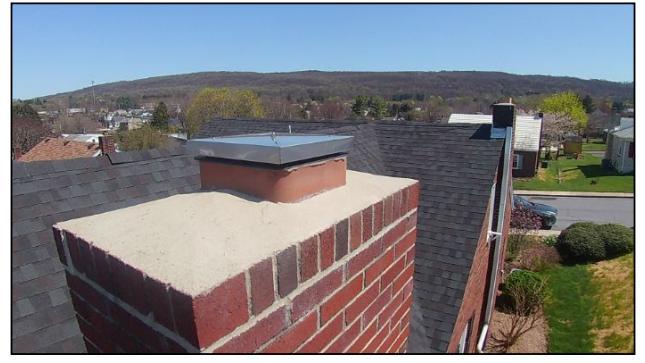
3.4. The back chimney had a cover that appeared to be the type that opens and closes in place of a chimney damper. You should ask the seller if this is the case, and if so, how it operates.

Rear chimney cap and cover

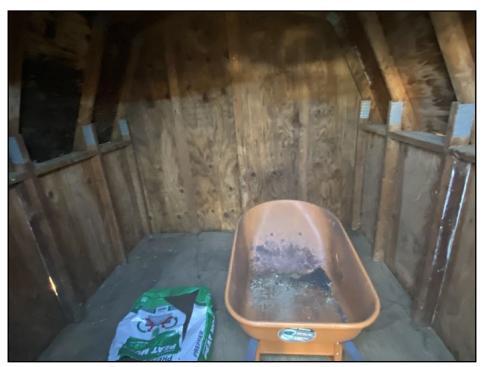
Rear shed interior

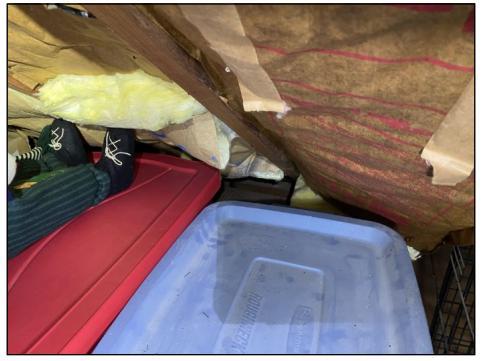
1.2. The occupant's belongings were stored in the front eaves storage space at the time of the inspection and blocked access to- and view of- portions of the roof structure. Comments made are based on the visible area able to be inspected.

Storage blocked access to under-roof spaces in the storage area

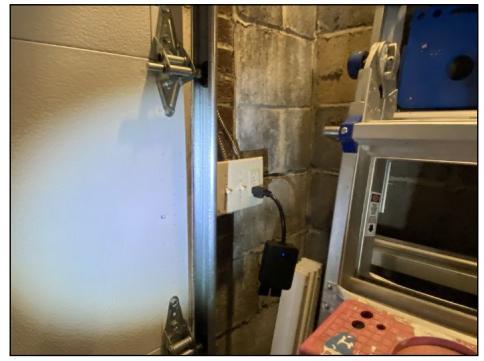
4.1. Electrical receptacles in the garage had Ground Fault Circuit Interrupter (GFCI) protection that responded to testing in a satisfactory manner at the time of the inspection. The inspector tested a representative number of accessible receptacles only.

GFCI receptacle with light switches in garage

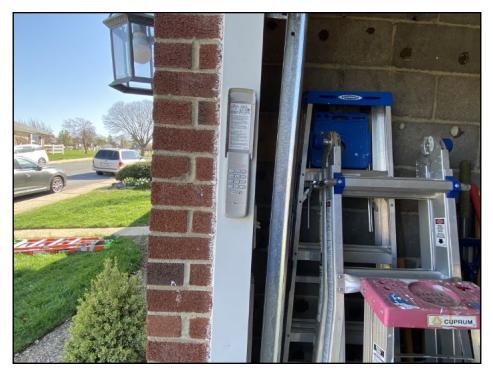
Exterior garage door opener

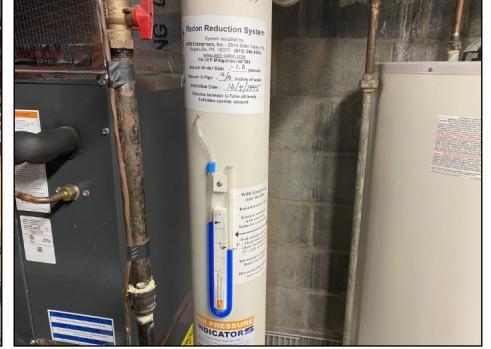
A radon mitigation system was installed in the basement; fluid levels indicate proper operation

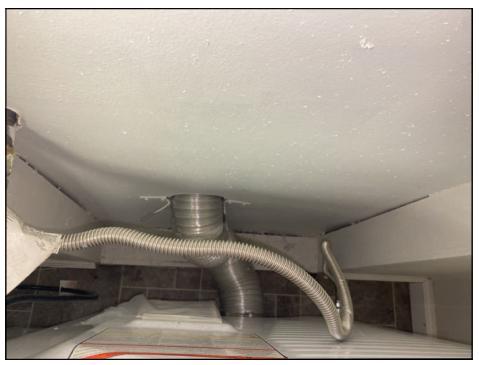
5.5. The dryer exhaust vent was not equipped with a backdraft damper. This condition may alow pests to enter the vent, where they may create obstructions with nesting materials, creating a potential fire hazard. The Inspector recommends installation of a proper backdraft damper.

Dryer exhaust vent

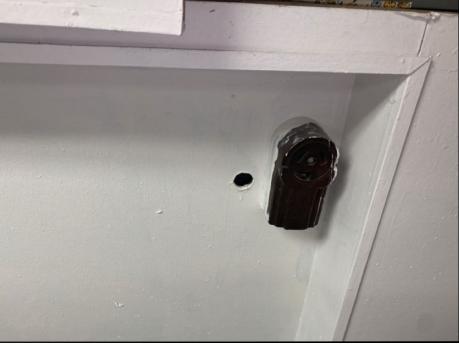
This 240 volt dryer receptacle was inoperable

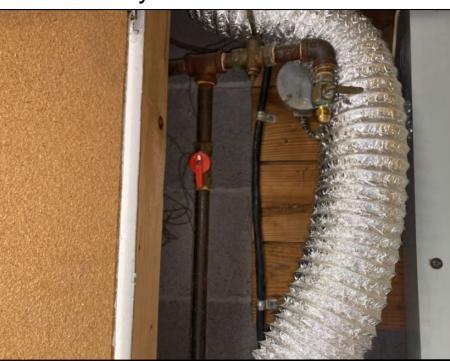
5.6. The dryer exhaust duct was kinked and/or crushed where it exited the back of the dryer. Space limitations made proper installation difficult. This condition creates a restriction in dryer exhaust that can result in lint accumulation or duct blockage, both of which are potential fire hazards. Restricted exhaust venting can also cause dryer overheating that can shorten the expected long-term service life of the dryer. Special hardware is available that is designed to allow proper venting in areas with space limitations. The Inspector recommends installation of an adapter that will not restrict dryer exhaust air flow.

Foil flex vent for dryer should be re-routed to be straighter

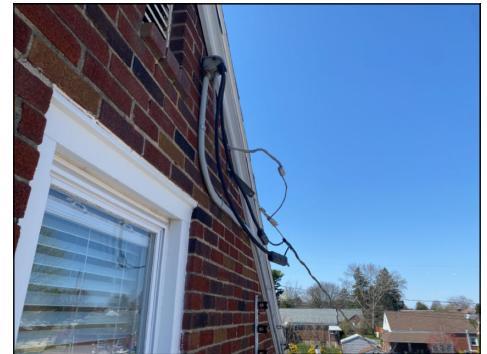
Service entrance and drip loop

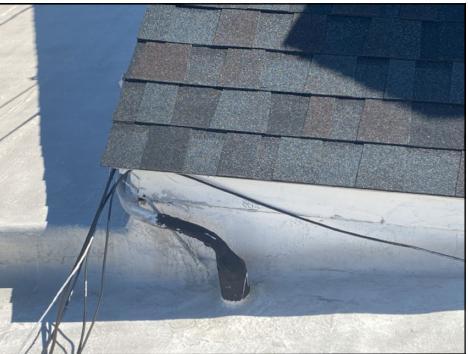
These service entrance cables to the meter should be regulary inspected

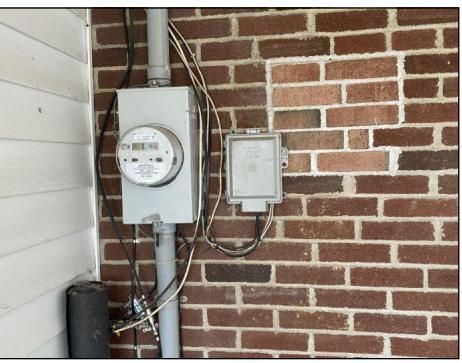
Electric meter was located on the back patio

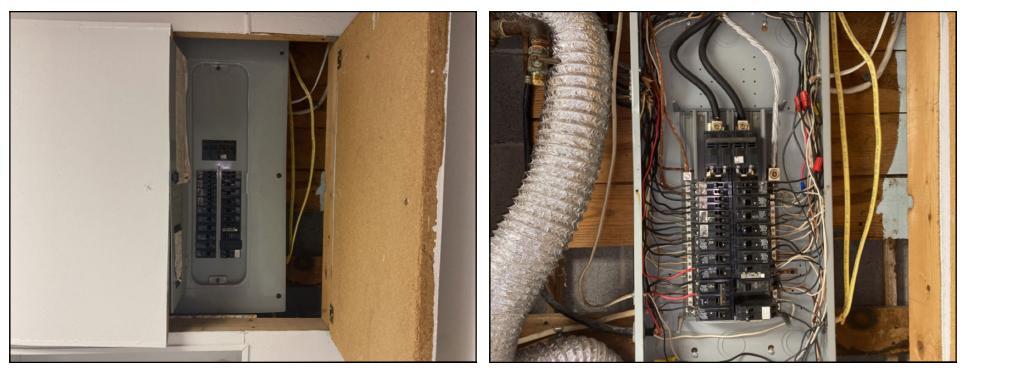
2.4. The service panel did not have proper clearances to provide quick access for an emergency disconnect. This condition should be corrected by a qualified electrical contractor. The clear working space required in front of a panel is 30" wide by 36" deep with a minimum headroom clearance of 6 feet-6 inches.

Open electrical panel

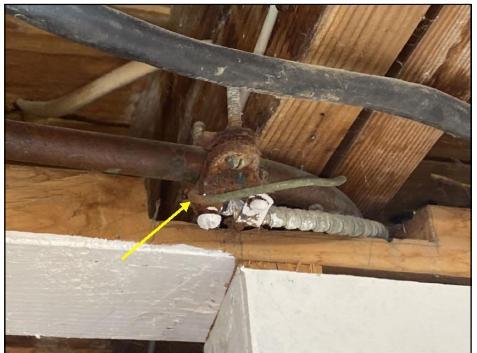
Water supply bonding to electrical system

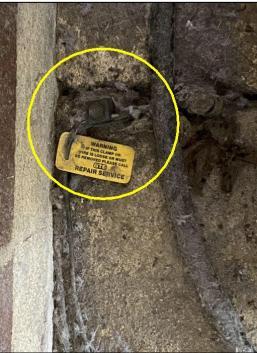
Grounding electrical conductor rod was installed under the electric meter in the back of the home

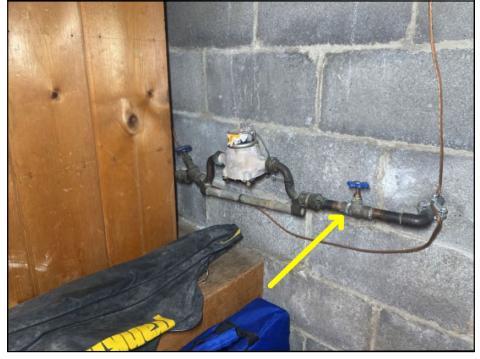
The main water supply shutoff is pictured

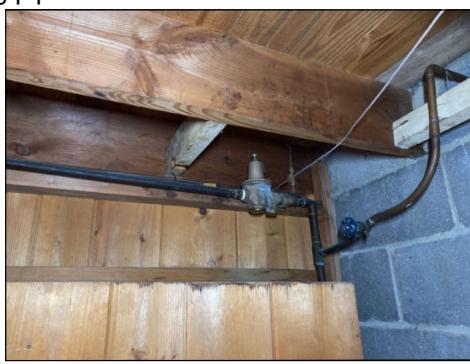
Water system pressure regulator and backflow preventer

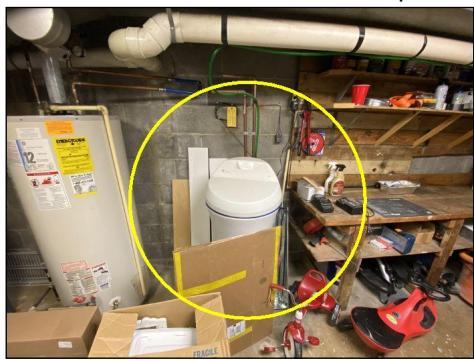
2.1. The home had a water softener that was disconnected; it was not inspected.

A water softening system was disconnected

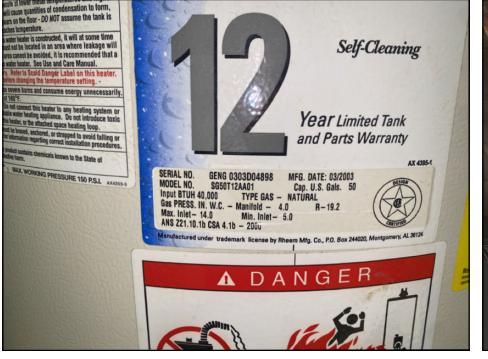
Water heater data plate

5.12. This water heater appeared to be past its design life and may need replacement soon.

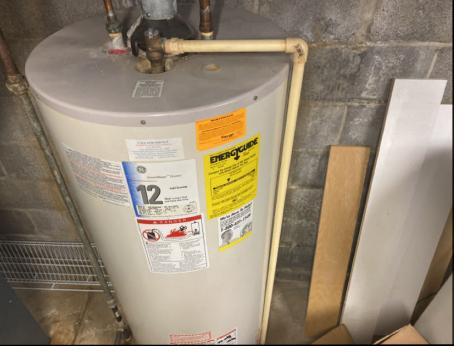
5.8. At the time of the inspection, the Inspector observed no deficiencies in the condition of the temperature/pressure relief (TPR) valve (not tested) and the TPR discharge pipe.

TPR valve and discharge pipe

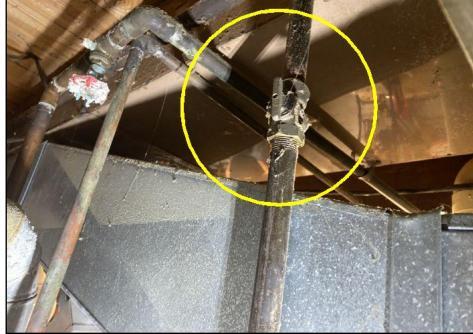
Water heater gas shutoff valve is

located behind the ductwork over the

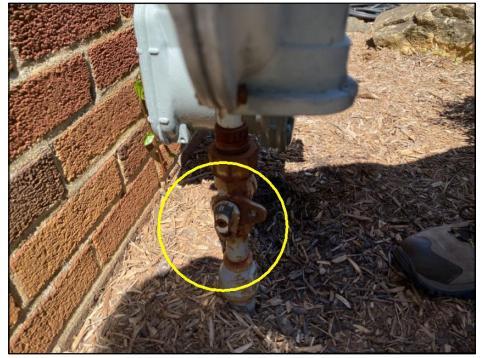
Gas shut-off valve in front of home

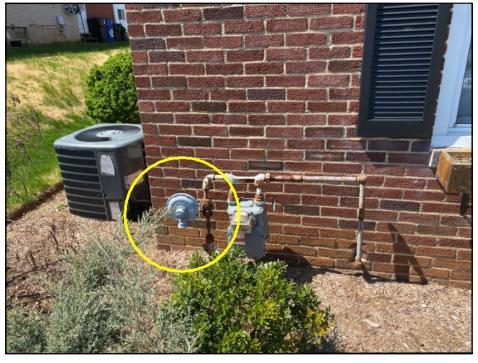
6.7. The photo shows the gas pressure regulator that controls the pressure under which gas is supplied to the home. Gas regulators leak small amounts of gas occasionally. If gas smell is strong and persists, contact your local gas utility provider.

Gas meter in front of home; the gas regulator is circled

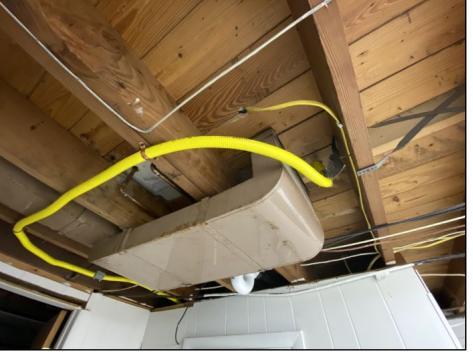
6.6. The home had corrugated stainless steel tubing (<u>CSST</u>) installed as gas pipe that was not electrically bonded. CSST has specific bonding requirements that must be complied with for safety reasons. Consult with a licensed plumber to evaluate and/or correct this condition.

This CSST fuel supply line to the kitchen gas range was not electrically bonded to the electrical system ground

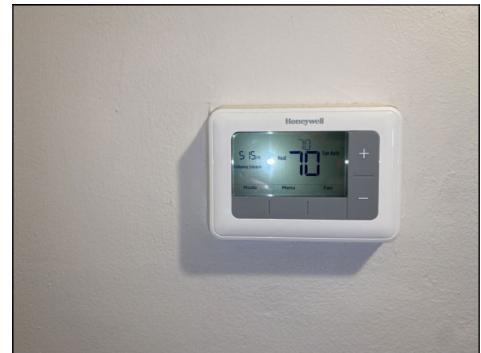
Thermostat is located in the upstairs bedroom hallway

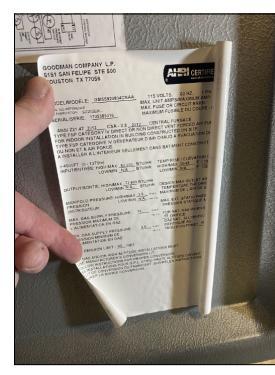
Furnace data plate

- 1.3. This furnace was made by Goodman, manufactured in May, 2017.
- 1.4. The heater was located in the basement.
- 1.5. Thermostats are not checked for calibration or timed functions.
- 1.6. The thermostat for this furnace was located in the upstairs hallway .

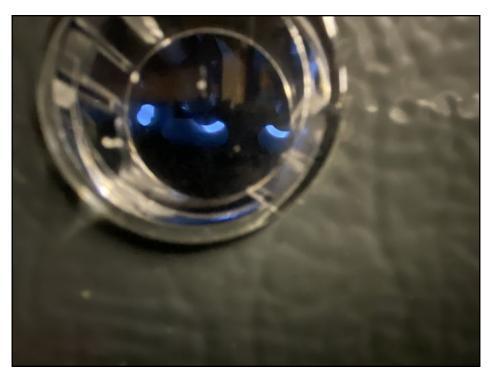
Furnace burner flame color is a uniform blue, indicating proper combustion

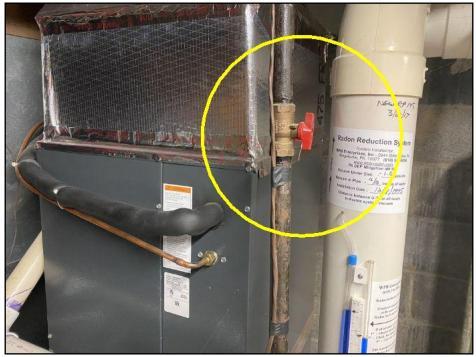
5.1. At the time of the inspection, the Inspector observed no deficiencies in the condition of the gas supply at this furnace.

Furnace gas shutoff valve

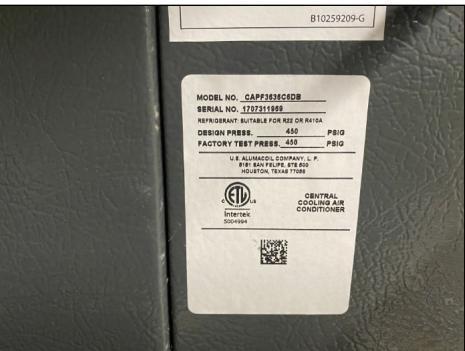
AC evaporator coil data plate

1.5. The air-conditioner date of manufacture was July 2017; the model number was CAPF3636C6DB; the serial number was 1707311969.

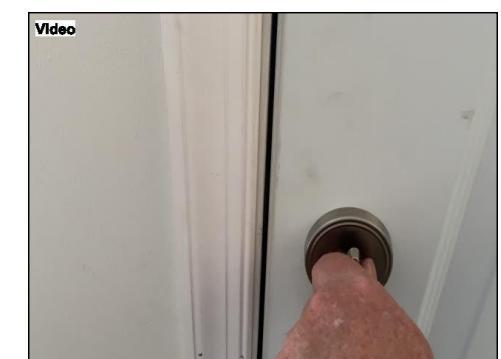
2.1. The front door deadbolt did not fully extend into the door frame as designed. The deadbolt did secure the door from the outside, but the bolt is only touching the strike plate instead of seating inside the frame. This condition should be corrected.

The front door deadbolt did not fully extend into the door frame

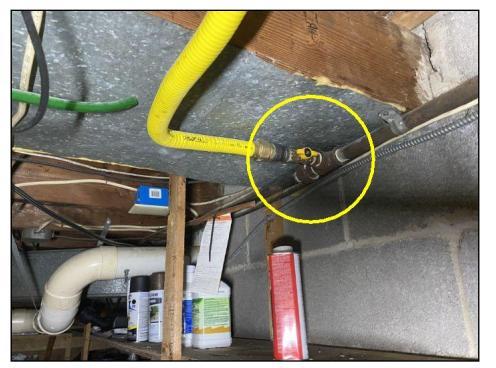
Gas shut-off for the gas range was located in the basement utility room

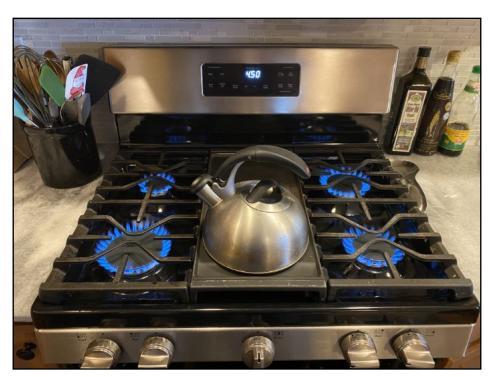
Range top burners are functional

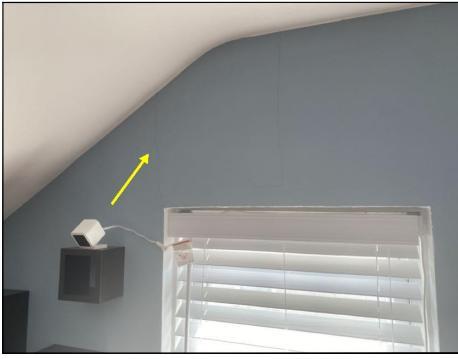
2.2. Minor cracks at the corners of doors and windows in walls in a bedroom appeared to be the result of long-term settling. Some settling is not unusual in a home of this age and these cracks are not a structural concern. They should be repaired and repainted. LOCATION: upstairs front bedroom

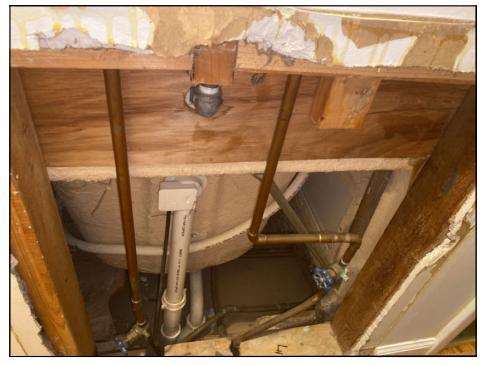
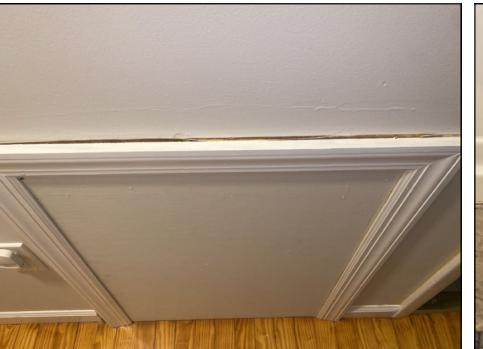
Behind upstairs bathroom access panel Access panel to upstairs tub plumbing in hallway

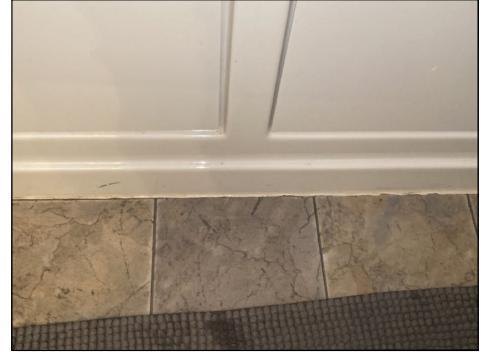
3.3. Sealant at the tub/shower was old and had visible discoloration consistent with microbial growth such as mold. The Inspector recommends that this sealant be removed and replaced to help prevent the development of unhealthy conditions.

Tub caulk in the upstairs bathroom needed to be reapplied
